INFRARED THERMOGRAPHIC INSPECTION OF ELECTRICAL JUNCTIONS IN SOME ELECTRICITY DISTRIBUTION FACILITIES IN AHMADU BELLO UNIVERSITY

Abdelmalik, A. A., Muhammed, M. I., Muhammad, A. B., Ismaila, A. and Aliyu, A.

Department of Physics, Ahmadu Bello University, Zaria, Nigeria.

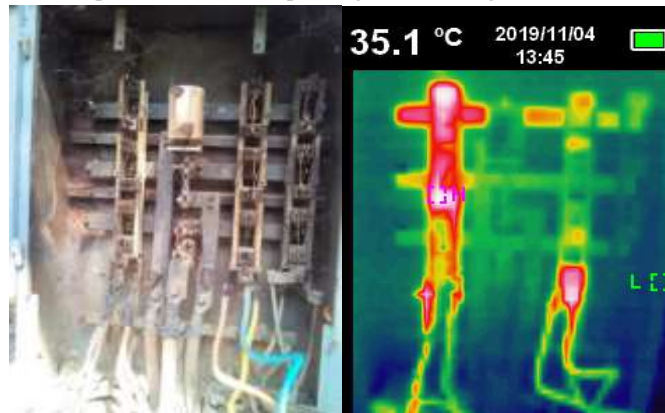
Figure 2 shows the photo of the feeder pillar and the corresponding thermal image.

Figure 2: Thermal image of feeder pillar showing the hotspots.

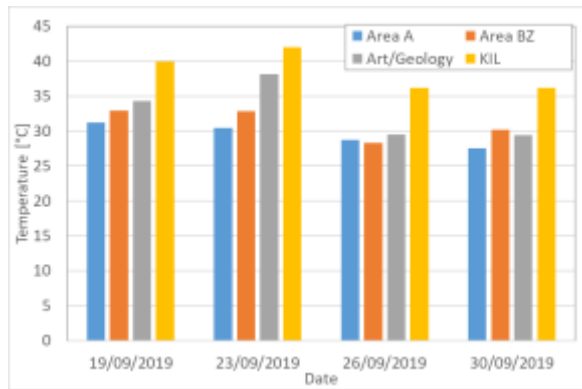
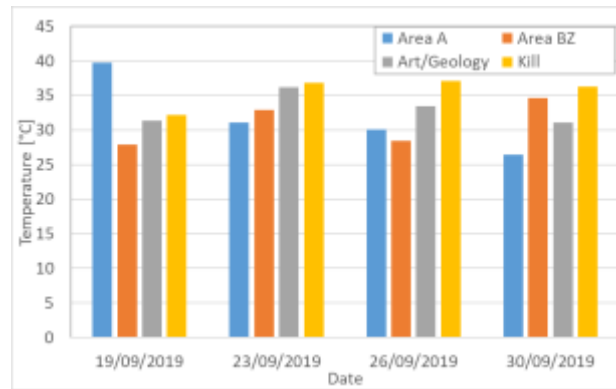
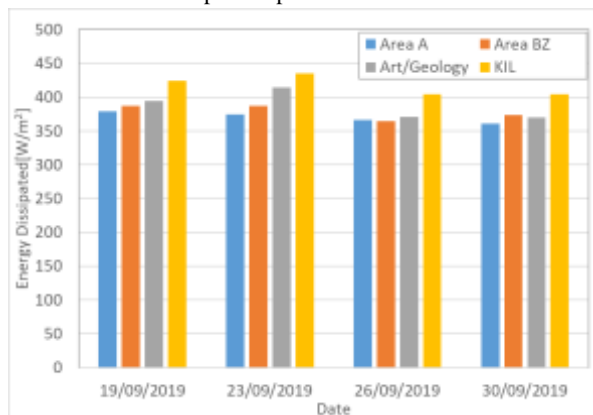
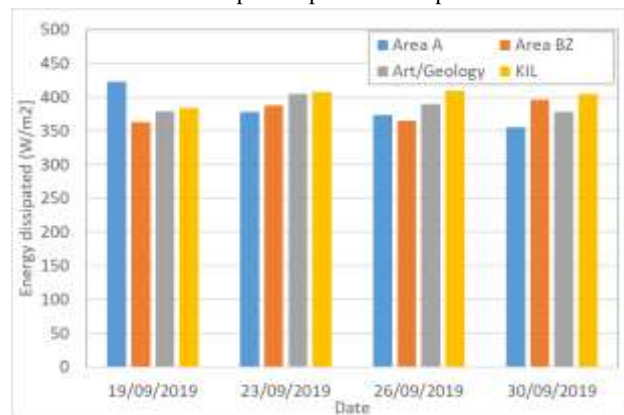
Figure 3: Thermographic inspection of feeder pillars

Figure 3 shows the bar charts of the thermographic inspection of the feeder pillars. Figures 3a and 3b show the temperatures of the detected hotspots of the loaded phase at 12 pm and 5 pm and the corresponding energy dissipated in the form of heat is shown in 3c and 3d respectively. The feeder pillars were observed to be in normal condition as the hotspot temperatures are below 40°C, which is within the acceptable limit. The presented heat loss (energy dissipated) in bar chart was calculated using Stefan’s Boltzmann law. The dissipated energy at the feeder pillars serving residential areas around 5 pm is slightly higher than that by noon. This is likely due to an increase in load at the

residential area after work hours. The dissipated energy was found to be between 355 W/m² and 422 W/m². Meanwhile, the dissipated energy at the feeder pillars serving the academic areas is higher around noon when compared to that around 5 pm. This may likely be due to a reduction in load.

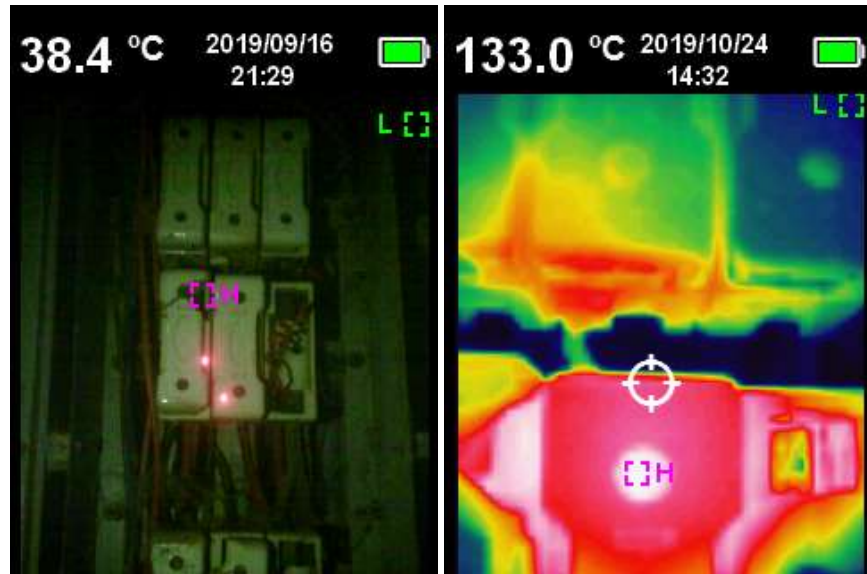
Figure 4 shows a picture of the thermal image of the main distribution board. Figure 4(a) shows the picture of the three-phase distribution board that supplied electricity to the three floors of the department while 4(b) shows the thermal image of the hotspot of the distribution board with hotspot temperature of 133°C.

Figure: 4 (a) three-phase distribution board, (b) thermal image of the main distribution board

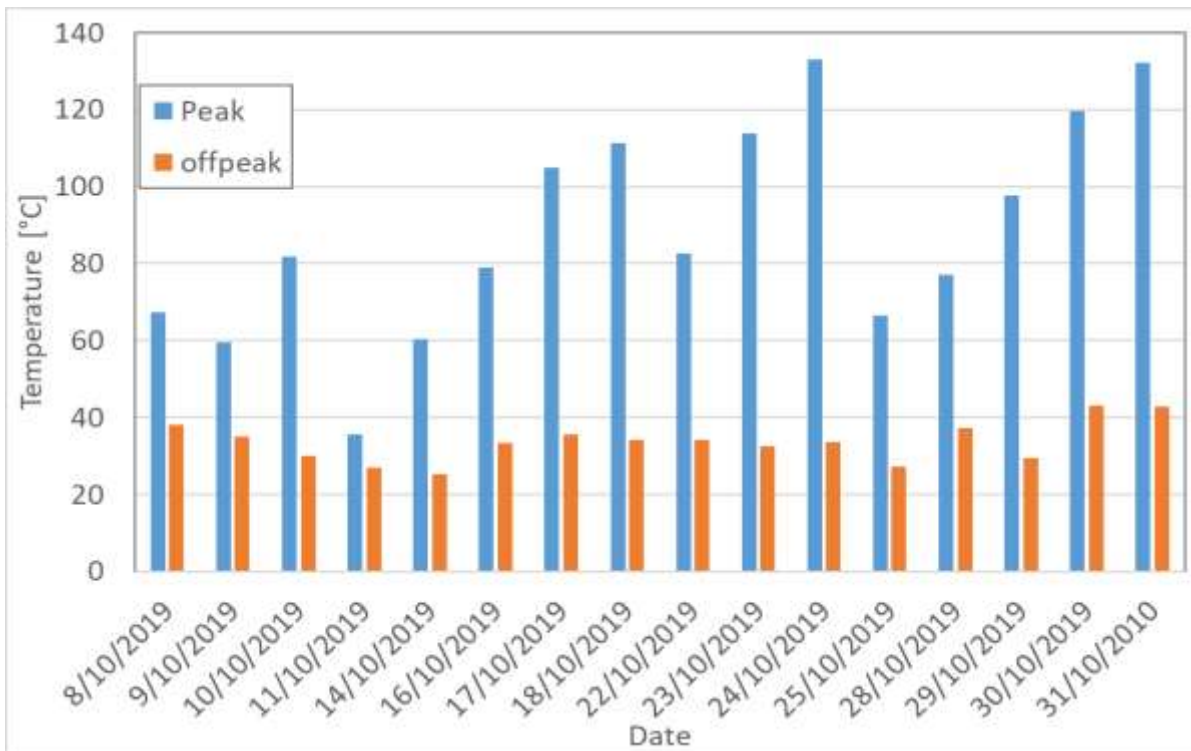
Figure 5 shows the bar chart of thermal readings of the distribution board during the assumed periods of possible maximum and minimum loading respectively. A large difference was observed between the measurements taken during work and after work hours. The mean temperature of the distribution board for the building after work hours was determined to be 33.7°C. With this temperature, the DB is considered to be in the normal operation mode. On the other hand, the temperature of up to 133°C was recorded from the DB. The temperature of 35.7°C that was recorded during the period

designated as peak period was measured around 4:00 pm just after the electricity supply was restored (having seized for some hours on that particular day). On the three-phase distribution board for the building, an average temperature of 92.4°C and 33.7°C were recorded during the peak and off-peak periods respectively. This heat energy generated in the electrical junctions of the distribution board stems up from the conversion of charge carriers of a conductor to thermal energy during the passage of electric current.

Figure 5: Hotspot temperature of the three-phase distribution board

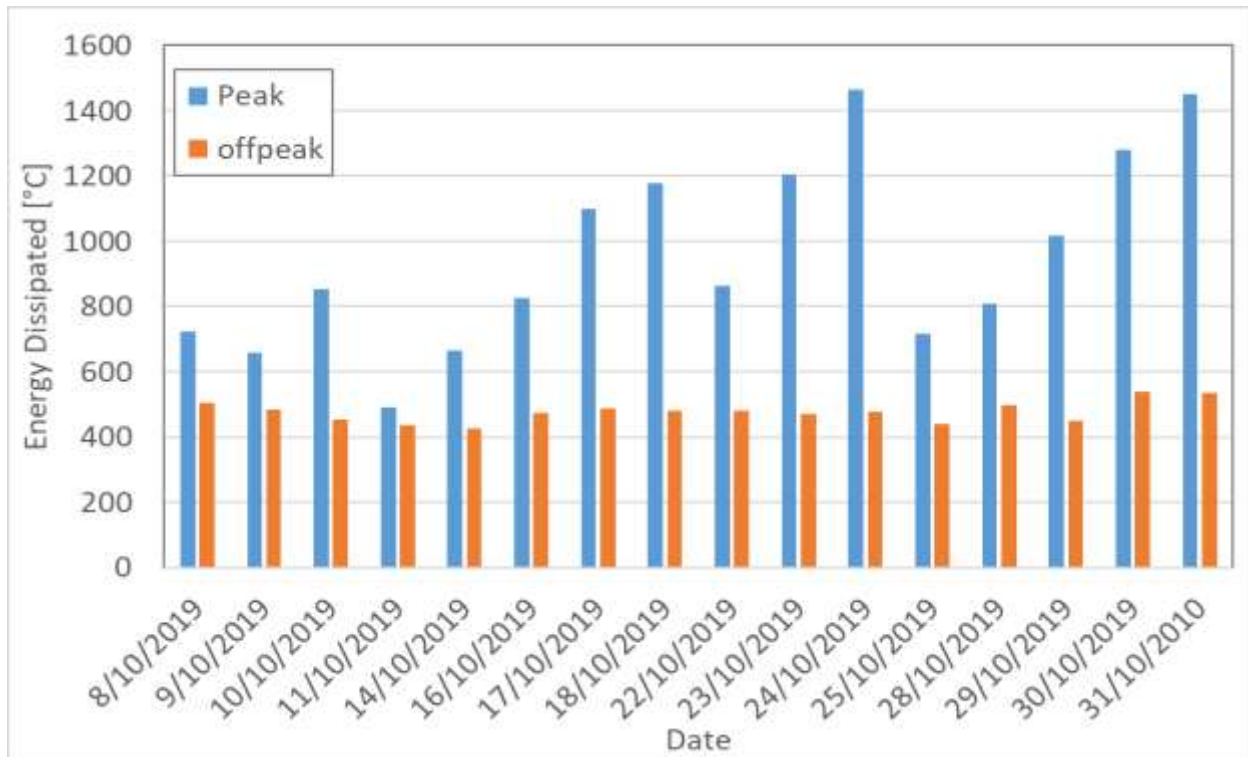
Figure 6 shows the bar chart of energy dissipated at the distribution board during the assumed period of maximum and minimum positive loading respectively. The energy dissipated

at the distribution board after work hours is relatively stable with a mean value of 477 W/m². The dissipated energy during the peak period ranges from 665 W/m² to 1.5 kW/m². The average energy dissipated as heat during the period studied was evaluated to be 1 kW/m².

Figure 6: Energy dissipated at the three-phase distribution board
