## GEOSCIENTIFIC SURVEILLANCE AND PERFORMANCE ASSESSMENT OF BOSSO DAM, NORTHCENTRAL NIGERIA

### ABSTRACT

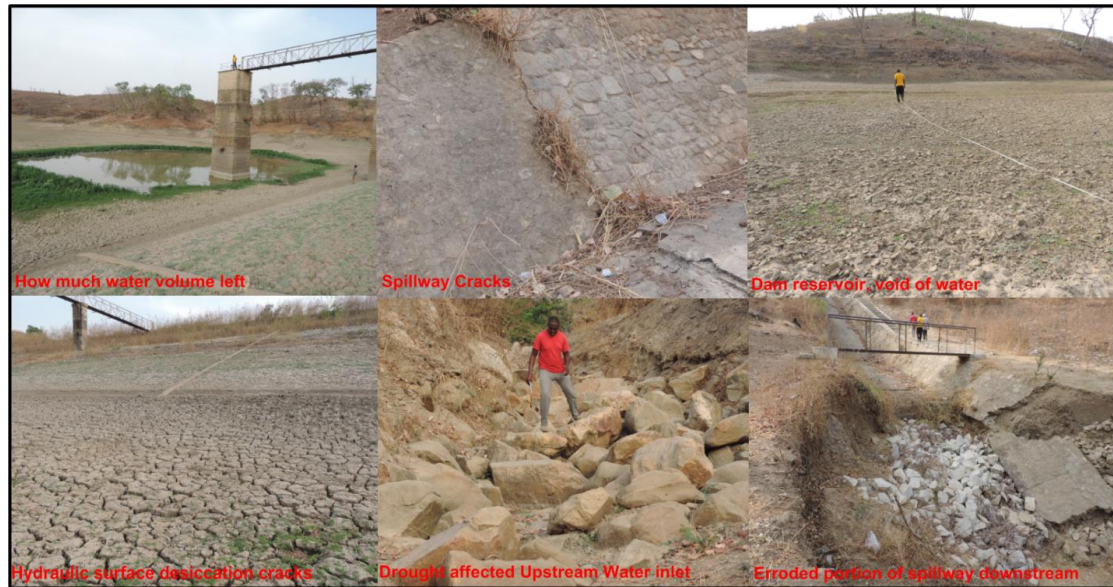
Plate 1: Different Aspects of Bosso dam Deficiency

The rock pitching to resist erosion in the upstream and downstream embankment faces have been overgrown by grasses of different varieties. The downstream portion of the dam is exposed to erosion and as a result of this the downstream portion suffered from occurrence of deep gullies and cracks which could affect the stability of downstream slope (Plate 1). The spill way channel is suffering from cracks and erosion activities (Plate 1). The reservoir drawdown as at the time of this investigation is almost zero.

Some existing or developing dangerous conditions were identified and potential challenges which might serve as risk to the downstream areas were also observed. Three general problem types were identified in-situ which suggest that the dam might be internally and physically challenged resulting to improper functioning of the dam. A number of cracks and structural damage were visually observed on the spill way barrier and on the spillway channel (Plate 1). Part of the spillway is already overtaken by erosion activities which suggest inadequate erosion protection. The mechanical appurtenant structures are currently in deteriorating stage. The discharge outlet is in a structurally deformed state (Plate 1). This may be attributed to old age and lack of maintenance. This deterioration of the structures could cause absolute failure of the dam or its components and severe damage to downstream properties, or even death of downstream residents which are noticed to be very proximate to the dam, about 300 m away from the dam site.

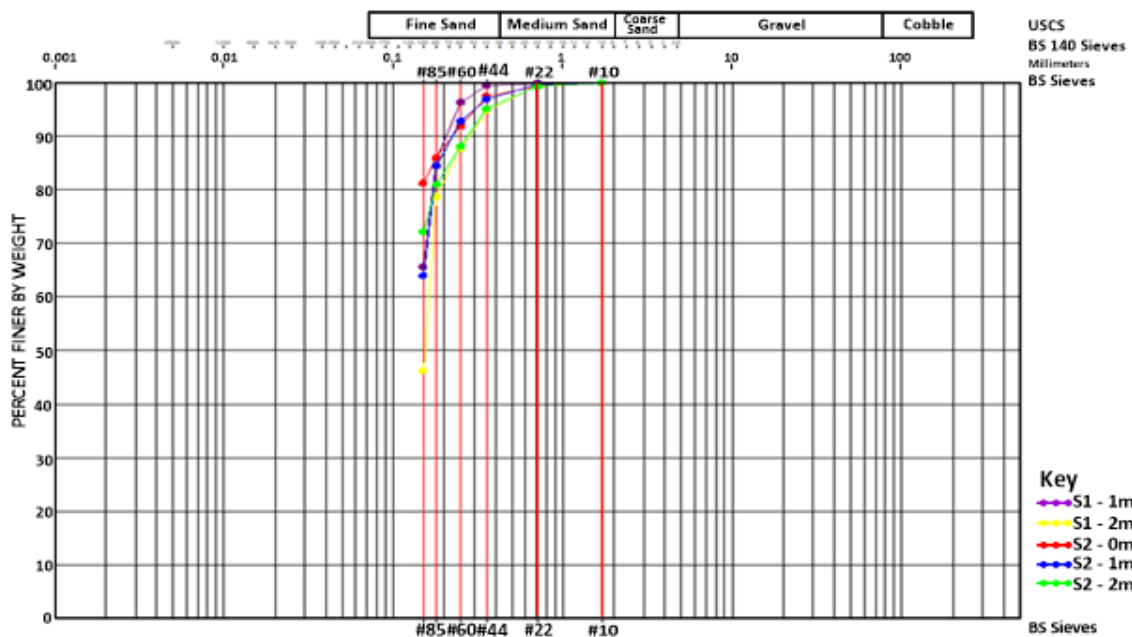
Figure 1: Sieve Diagram

5 soil samples were collected from 2 trial peats (2 samples from peat 1 and 3 samples from peat 2). Samples were collected at the surface, 1m and 1.5 m interval below the reservoir. The grain size distribution data and curves obtained by sieving are shown on Table 1 and Figures 1. This soil classification analysis is in agreement with the material tactile-visual analysis. The availability of sand and the predominance presence of silt attributes the soil, its particular characteristics. This suggests that the dam reservoir might be prone to leakage considering that silt or silty-sand are cohesionless soils.

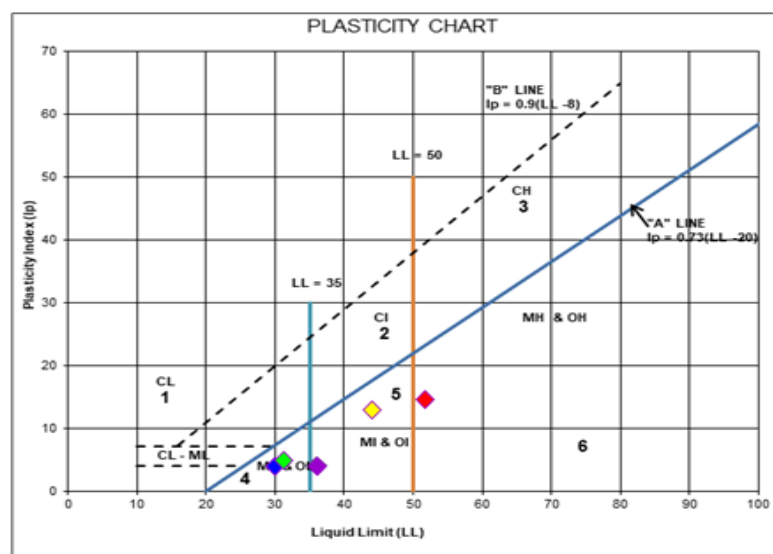
Figure 2: Plasticity Chart

The liquid and plastic limits tests were performed on samples collected from the trail peats and results obtained are summarized in Table 2.0. The USCS classified the analyzed soil as ML, MI, MH (low, medium and high plasticity silt)

(Figure 1) which are in contrast with similar work by Berhane *et al.*, (2017) which indicated CH and CL soil of low permeability and high plasticity as suitable soil to underlain earth dam reservoir.

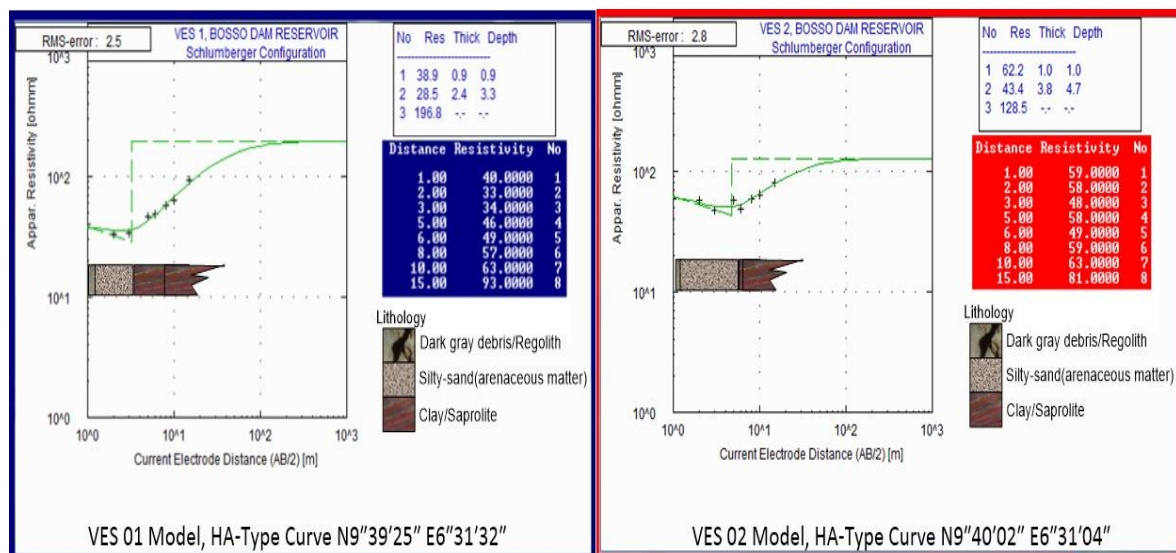
Figure 3: VES Curves

The VES results shows that the subsurface lithology is remarkably inhomogeneous in composition. The geoelectric section indicates three (3) lithologic layers defined by top dark debris/regolith forming decagonal cracks with geo-resistivity value range between of 39  $\Omega\text{m}$  and 62  $\Omega\text{m}$  to the depth range of 0.9 m to 1.0m. The second layer depth ranges from 3.3 m to 4.7 m composed of arenaceous components of silty-sand with resistivity value range of 29  $\Omega\text{m}$  to 43  $\Omega\text{m}$  and a thickness range of 2.4 m to 3.8 m. Clayey materials to saprolite underlain the third layer with geo-resistivity value range of 129  $\Omega\text{m}$  to 197  $\Omega\text{m}$ . From the result of the findings and field observations it is reported that the dam reservoir section is underlain by high level of argillaceous/arenaceous matter transported into the reservoir section via the inlet

streams with high porosity and potentially rife for great reservoir infiltration. Desilting the dam is very necessary if it must be retained at this stage.

The curves are HA model type. The geo-electric curve shapes and not the geo-resistivity values were employed in the geo-electric resistivity sounding data interpretation. This is because the values of resistivity may be altered due to saturation or moisture content of the lithology in response to seasonal variation (wet and dry seasons), but the absolute depths to geoelectric subsurface layers remain constant. Thus, curve shapes were utilized to infer for the subsurface geoelectric layers. Model interpretations of the VES results in the two established stations are indicated on Table 3 and the modeled geoelectric curve are shown in Figure 3

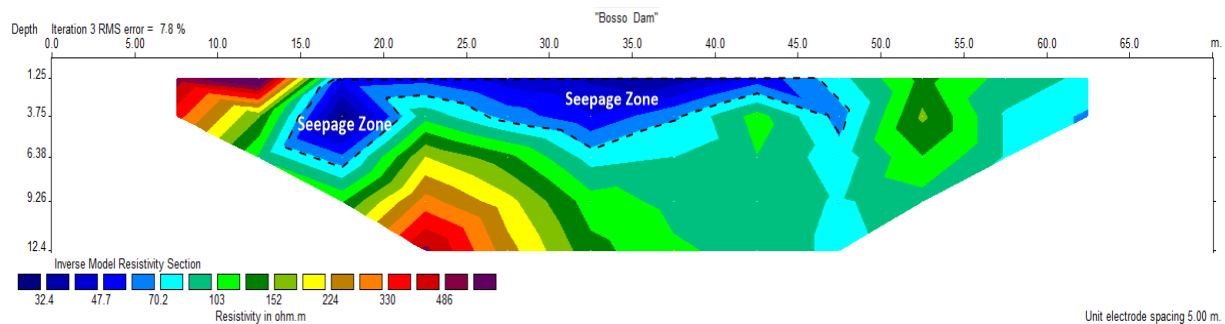
Figure 4: 2D Electrical Resistivity Tomography

The result of the subsurface ERT profile obtained along the dam toe at the downstream section converged to a maximum of 5.8% RMS error in five iterations. The geoelectric profile imaged the earth interior at the dam toe extending to an average depth of 12 m below ground level (Figure 4). The resistivity distribution along the profile ranges from about 30  $\Omega\text{m}$  to > 486  $\Omega\text{m}$ . Underlying the profile line from the surface distance of about 15 m to 45 m, the profile is delineated with distinct lenses of anomalous zones of low geo-resistivity values ranging from < 30  $\Omega\text{m}$  to < 70  $\Omega\text{m}$ . This finding

corresponds to the observation of the presence of aquatic vegetation (like cattails, reeds etc.), wet spots with normal vegetation further downstream the path of the moist subsurface. These low resistivity anomalous zones and the wet conditions noticed on the profile distance of 15 to 45 m downstream toe section of the dam embankment suggest the presence of possible seepage caused by internal erosion, excessive internal pressure and or saturation. The profile distance of 0 m to 15 m shows no signs of low resistivity (>300 ohm-m), indicating a no seepage zone.
