## Geological, Geophysical and Geotechnical Investigations of Road Failure along Keffi – Nasarawa Road, Northcentral, Nigeria

### ABSTRACT

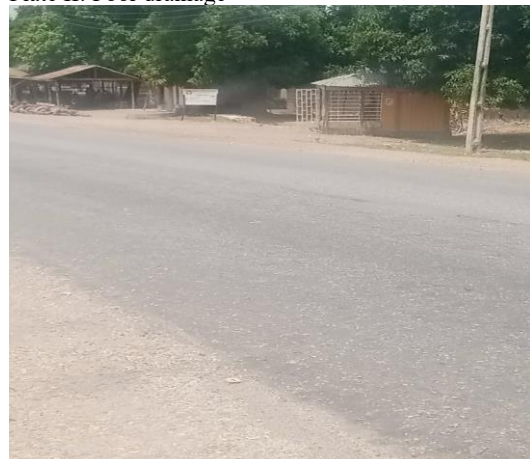
Plate IV: Stable part
