## Geological, Geophysical and Geotechnical Investigations of Road Failure along Keffi – Nasarawa Road, Northcentral, Nigeria

\*Osuorji, Gideon C., Oleka, A. Baba, Obrike, Steve E. and Ubugadu, A. Abdullahi

Nasarawa State University, Keffi

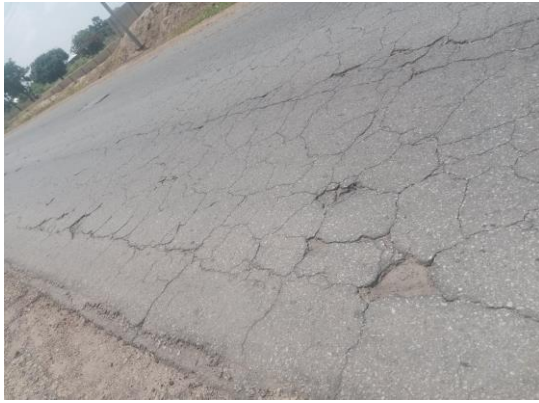
Plate I: Alligator cracking

**Pavement Distress:** This type of failure includes cracks, potholes, rutting, and uneven surfaces as seen in plate I.

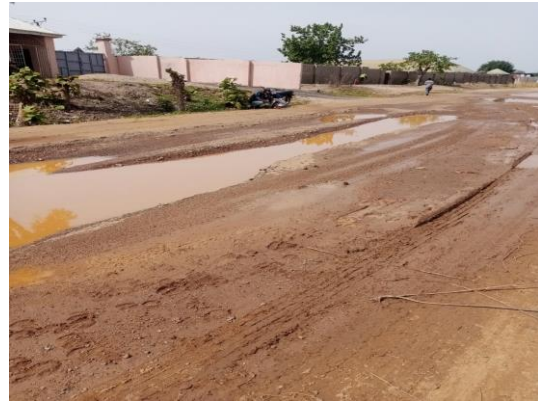
Plate II: Poor drainage

**Drainage Issues:** This comprises water accumulation, erosion, or damage due to improper drainage as seen in plate II

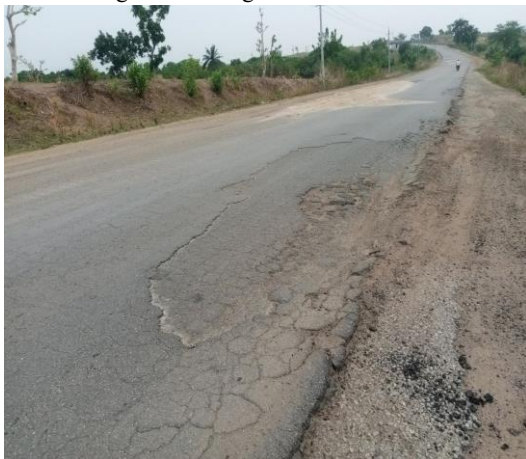
Plate III: Edge failure/deterioration

**Surface Deterioration:** This type of failure involves wear and tear, oxidation, and damage from weather and traffic as seen in plate III.

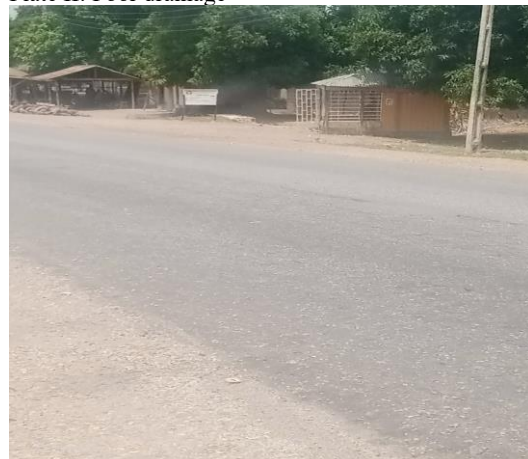
Plate IV: Stable part

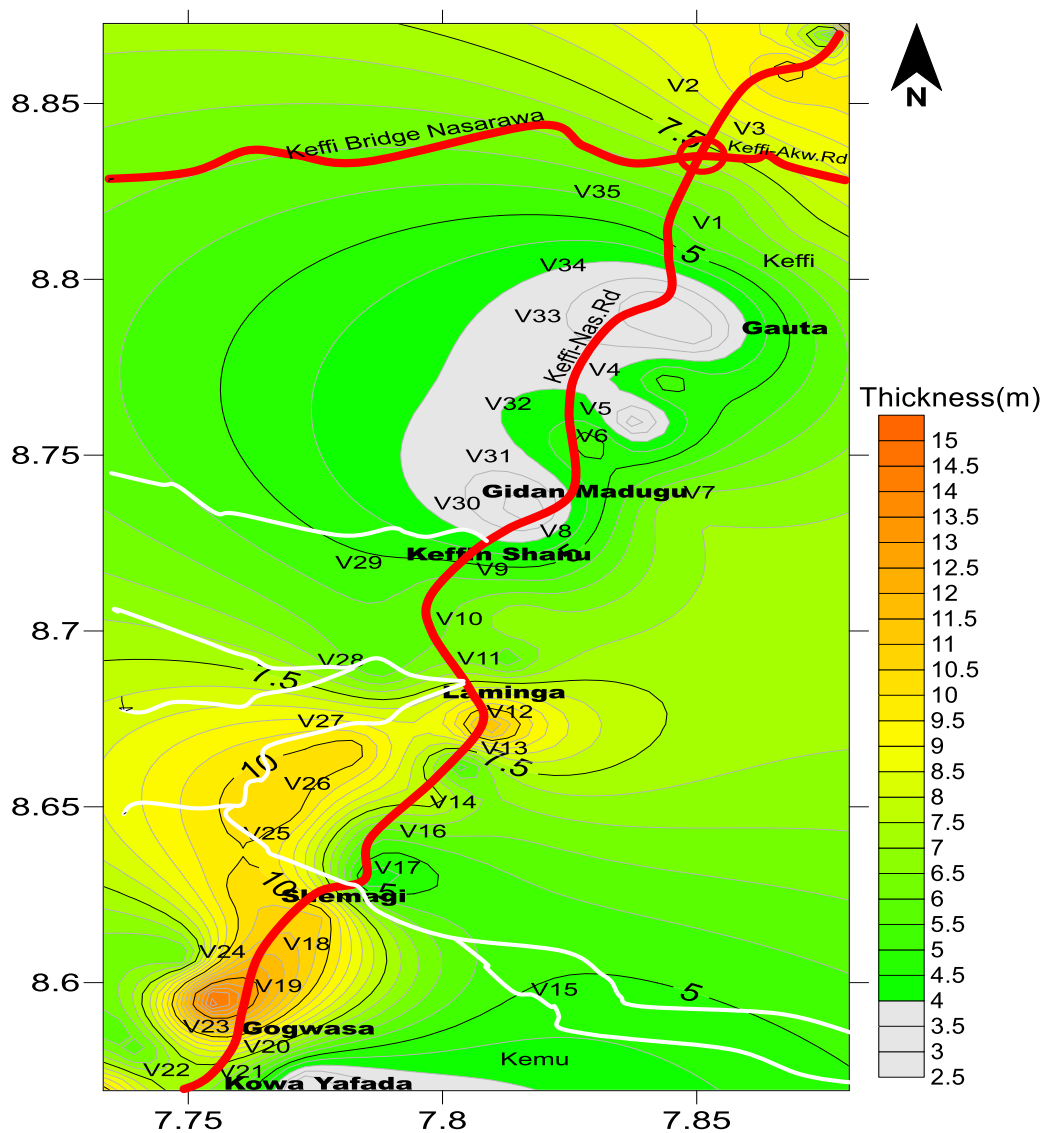
Figure 6: Iso-thickness overburden map of the study area

From the interpretation of the data conducted at the geo-electric layer, two zones were delineated, Zone-1 covers an area with a relatively low thickness value (<8 m), and Zone-2 is characterized by moderate to high thickness (9-13m). The boundary between the two shallow zones with contrasting geo-electrical behavior trends in the E-W direction.

The resistivity of the clayey weathered layer varies from 59–120 Ohm-m with thickness in the range of 2.5-8 m. The thickness and resistivity of the underlying thick overburdens suggest laterite as a result of the type of pre-existing parent rock (granite-gneiss, Migmatite) in the sounding location along the Keffi-Nasarawa road. Thus, the geological condition of an area is a key factor for the stability of roads. The geo-electric layer (Overburden) thickness contour map shows the variation of thickness along the Keffi-Nasarawa

highway, the low thickness values are represented by gray-green color between 2.5-8.0m while moderate – high thickness values 9 – 15.0 m range from yellow–red. Comparatively, the pavement failure along the Keffi-Nasarawa highway can be attributed to several factors, including the presence of water-saturated zones beneath the surface, weathered formations, and the existence of clayey soil that becomes saturated. Other factors, such as poor drainage patterns, also contribute to the failure. On the other hand, the stability of another section of the highway can be attributed to the presence of a competent layer with a thick lateritic layer and a resistive topmost layer. Additionally, the type of pre-existing parent rock (granite and Migmatite) along the Keffi-Nasarawa highway plays a role in its stability.
