## DETERMINATION OF IMMEDIATE CAUSES OF 2017 FLOOD EVENT IN DADIN KOWA TOWN, GOMBE STATE, NIGERIA

Saheed A. Bello, E. D Mshelia, Peter Ogoja

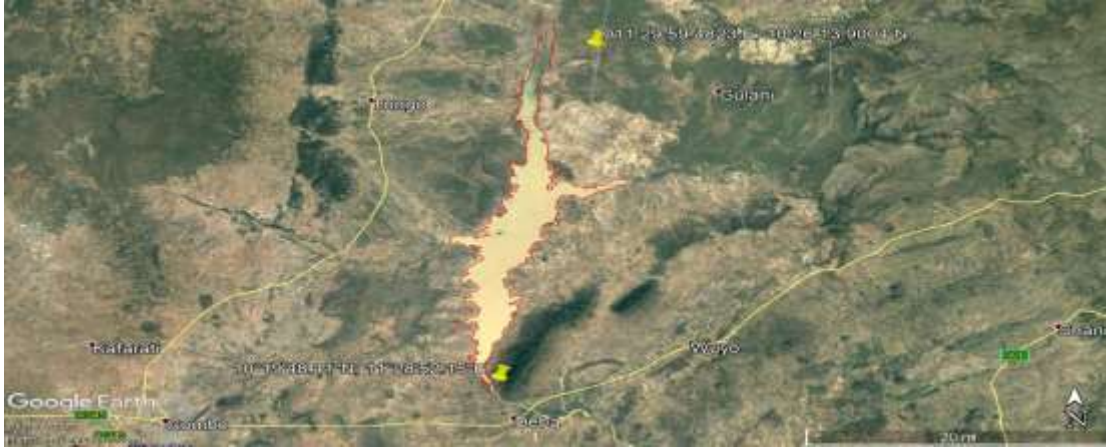
Figure 2: Dadin Kowa Dam

The Dadin Kowa Dam is located along Gongola River in present Gombe State it flows in from Plateau Inland; it belongs to the Upper Benue River Basin Development Authority of Nigeria (As shown in Figure 1). According to Upper Benue River Basin Development Authority (1983), Dadin Kowa dam is a multipurpose earth fill dam located some 5 km North of Village of Dadin Kowa on river Gongola in Gombe state. The maximum flood level is 249 m, the maximum supply level is 247meters and the minimum supply level is 239 meters the surface area of the reservoir is 300 km<sup>2</sup> with live storage of 1.77 billion cubic meters. The 1:10,000-year peak in-flow flood is 3,160 M<sup>3</sup>/Sec. and the peak outflow is 1,110 M<sup>3</sup>/Sec. The total catchment area of the Gongola River is approximately 56,000 square kilometers, 58.5 % of which lies upstream of the dam (As illustrated in Figures 1 and 2).

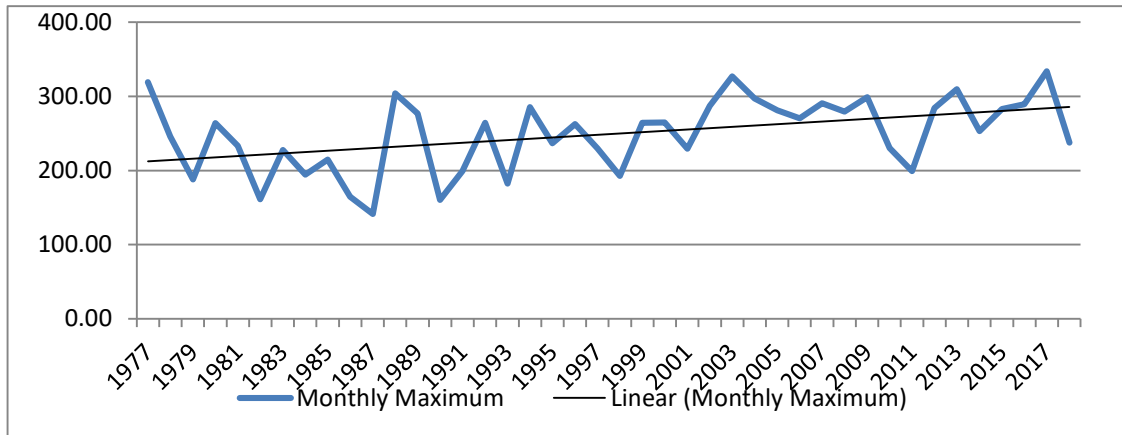
Figure 3: Monthly Max Rainfall of Dadin-Kowa reservoir basin 1977-2018 (UBRBDA-DADIN KOWA OFFICE).

rainfall data measured at Dadin Kowa town for each month of the year 1977 to 2018 were computed as shown in Table 1 and Figure 3, and the maximum rainfall of 344 mm was recorded in June, 2017, follows by 327.10 mm in July, 2003, the third maximum rainfall occurred in August, 1977 with 319.00 mm and the fourth and fifth maximum rainfall were 309 mm and 303 mm in September and August of the year 2013 and 1988 respectively. It is clear from these results that rainfall yield is

increasing in the study area (As shown in Figure 3). The increase does not show a distinct trend because there are fluctuations. This result seems to be in good agreement with the study of Yahaya (2015) and Ibrahim & Jauro (2016) that state that the rainfall yield is increasing in the North-East of Nigeria. The maximum rainfall of 344 mm coincides with June, 2017 in which flood occurred in the town. The implications of this show that the flood was rainfall-induced.

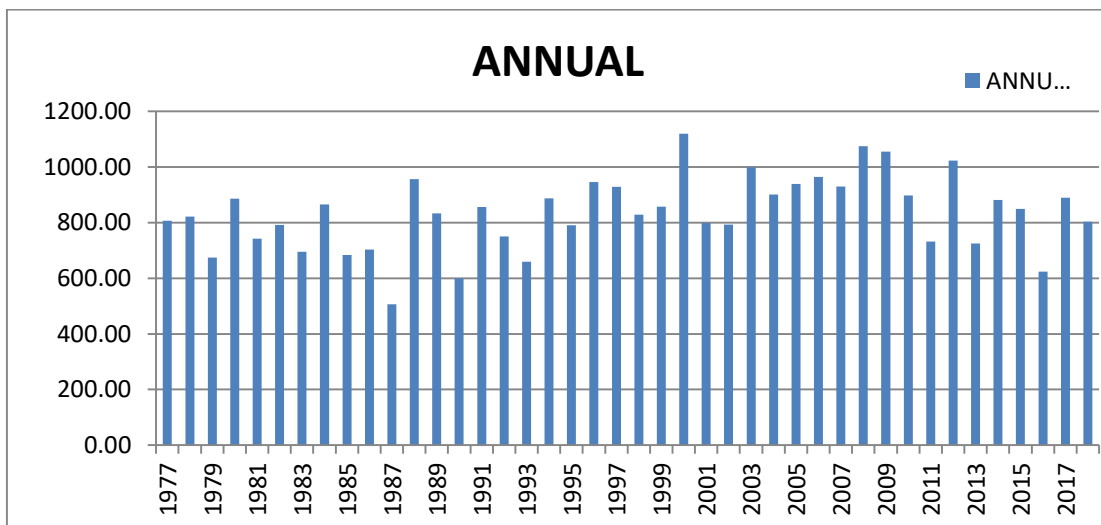
Figure 4: Annual rainfall of Dadin Kowa Dam between the years 1977 – 2018 (UBRBDA-DADIN KOWA OFFICE)

From Table 1 and Figure 4, the total annual rainfall measured at Dadin Kowa dam for the period 1977 to 2018 indicated the year 2000 annual rainfall of 1119.30 mm was the highest historical maximum annual rainfall following 1074.30 mm in 2008, and the third and fourth maximum annual rainfall was 1055 mm and 1022 mm in 2009 and 2012 respectively. The maximum annual rainfall of 2017 flood was the 14<sup>th</sup> maximum annual rainfall between 1977 and 2018. There was no information that the Dadin Kowa town got flooded in 2000,

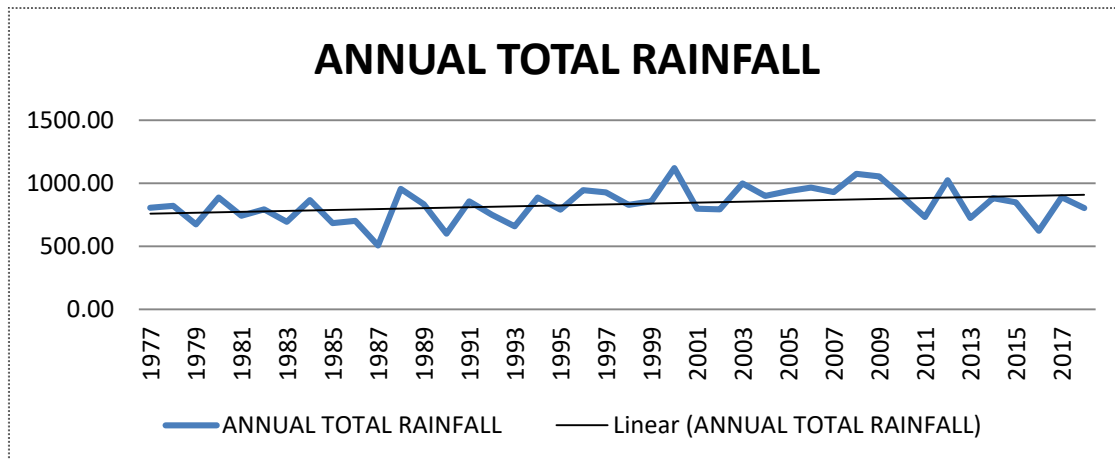
Figure 5: Total annual Rainfall of Dadin-Kowa Reservoir Basin between 1977-2018 (UBRBDA-DADIN KOWA OFFICE)

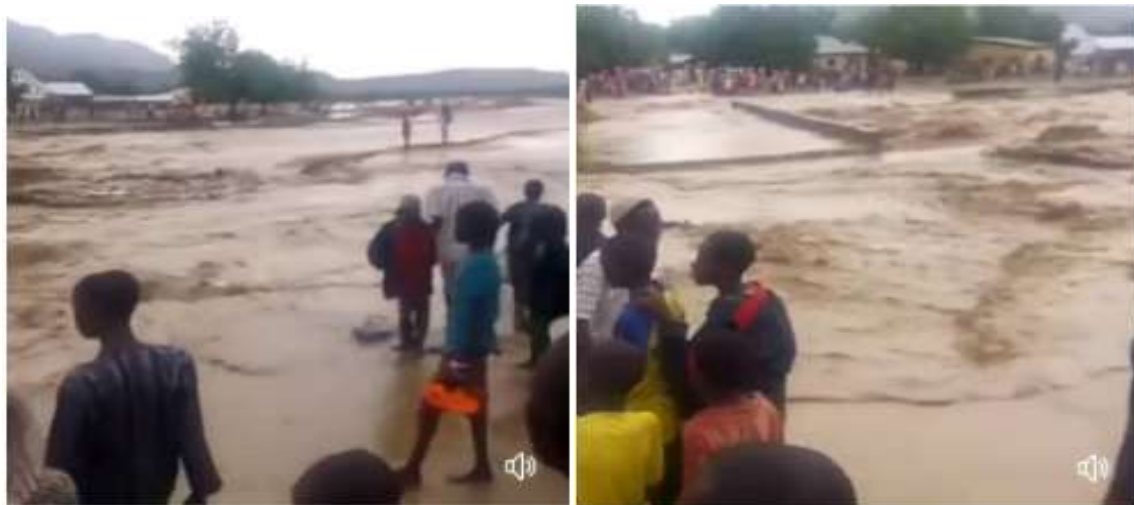
2008, 2009, 2012, 2003, 2006, 1988, 1996, 2005, 2007, 1997, 2004 and 2010 which have a higher maximum annual rainfall than 2017. But the level of urbanization and hence encroachment into the floodplain is higher in 2017 than in any of the years 2000, 2008, 2009, 2012, 2003, 2006, 1988, 1996, 2005, 2007, 1997, 2004 and 2010. The graphical presentations of the rainfall analysis as presented in Figure 5, indicated an upward trend in annual rainfall. This further explains that the 2017 flood was as a result of peak rainfall and encroachment into the floodplain areas as shown in Figures 6 a-b.

Figure 6a: Overflow Gada Dauda during the 2017 Dadin Kowa flood

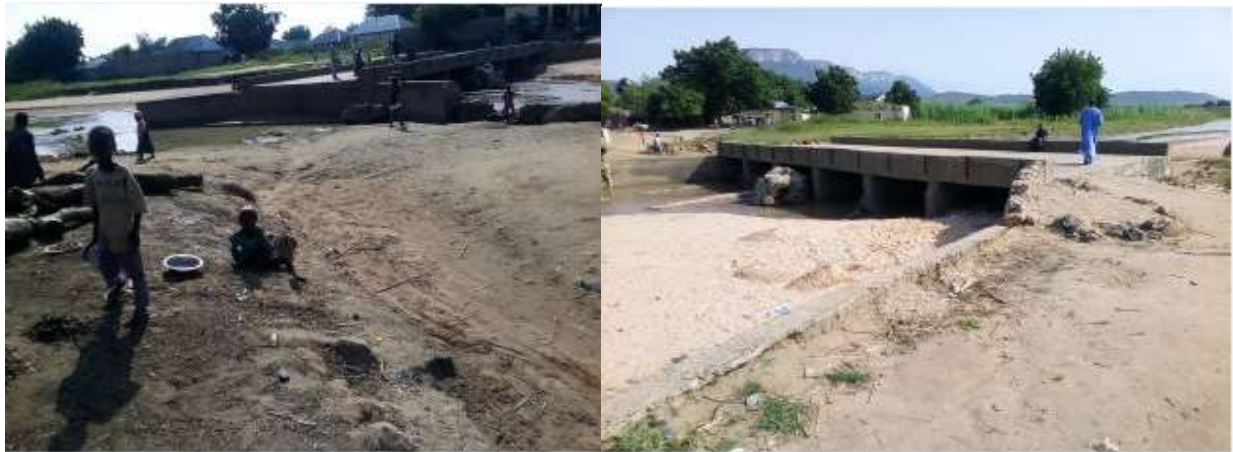
Figure 6b: Damaged Gada Dauda during the 2017 Dadin Kowa flood

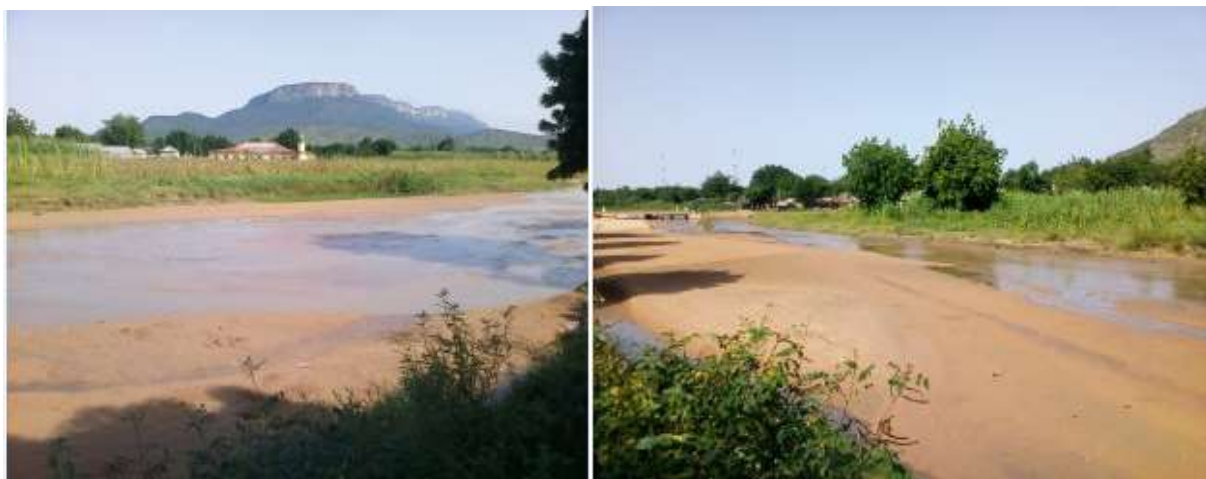
River Yelwa passes through Gada Dauda in the heart of Tunga, it flows into River Gongola at the downstream of Dadin Kowa. As shown in Figure 7, the level of siltation in the river channel is high and almost silted up, the river met obstruction at the junction (As shown in Figure 8) and then flows back into the town at the hour of the flood due to high rainfall and releases

Figure 7: River Yelwa and encroachment Area in the Flood prone

Evacuating people from the floodplain and dredging of the river Yelwa and River Nunu should be done to prevent future occurrence of flood events.

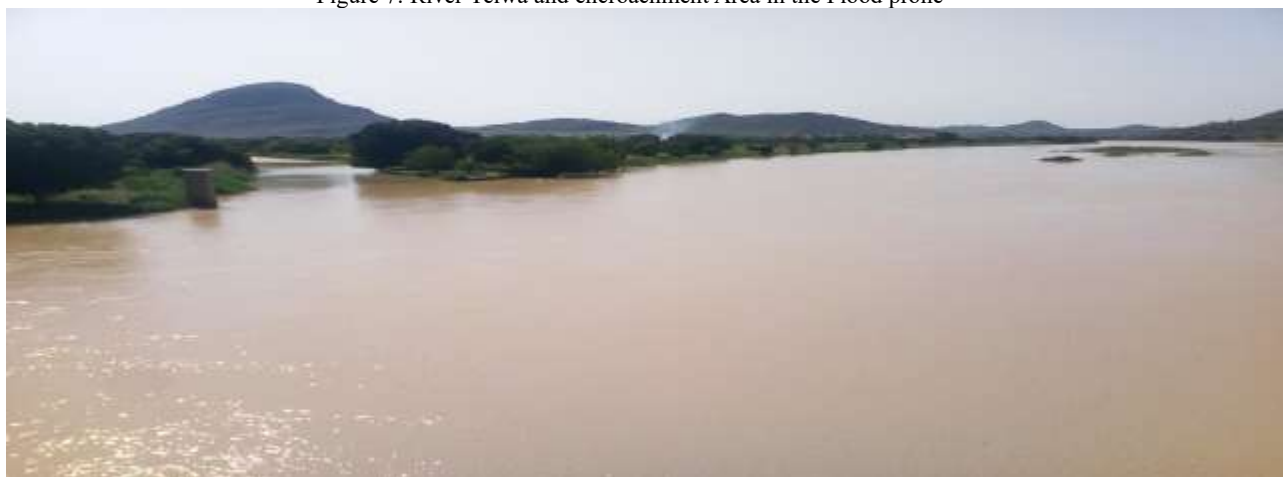
Figure 8: Junction of River Yelwa and Gongola River

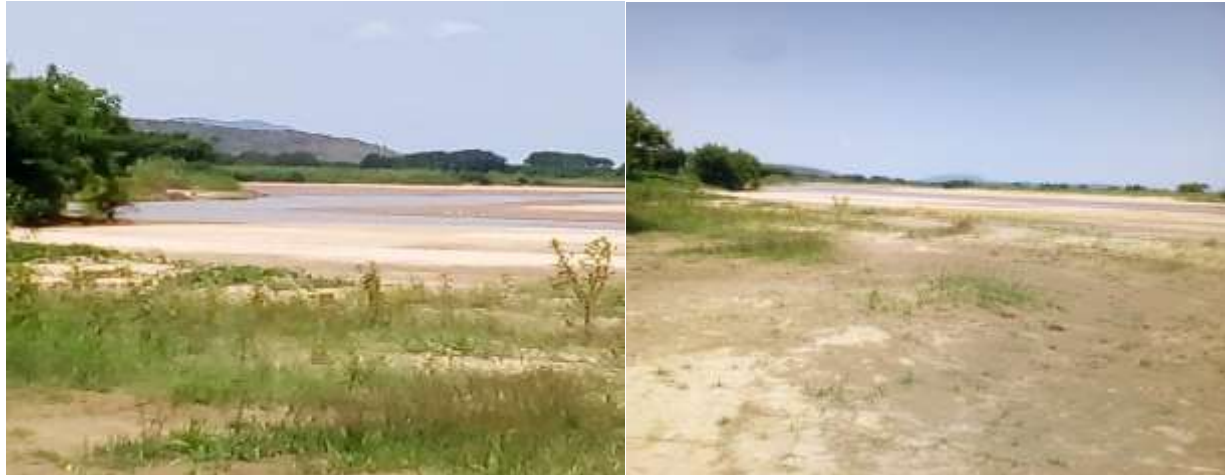
from the dam. River Nunu flows from Hore Gare into Gongola River through an irrigation site in Tunga. The river Nunu (As illustrated in Figure 9) is almost silted up and during the 2017 flood due to high rainfall and releases from Dadin Kowa Dam it overflows and got flooded around 60 % of irrigation sites both in faces 1 and 2. Also, the Hore Gare village was flooded.

Figure 9: River NuNu

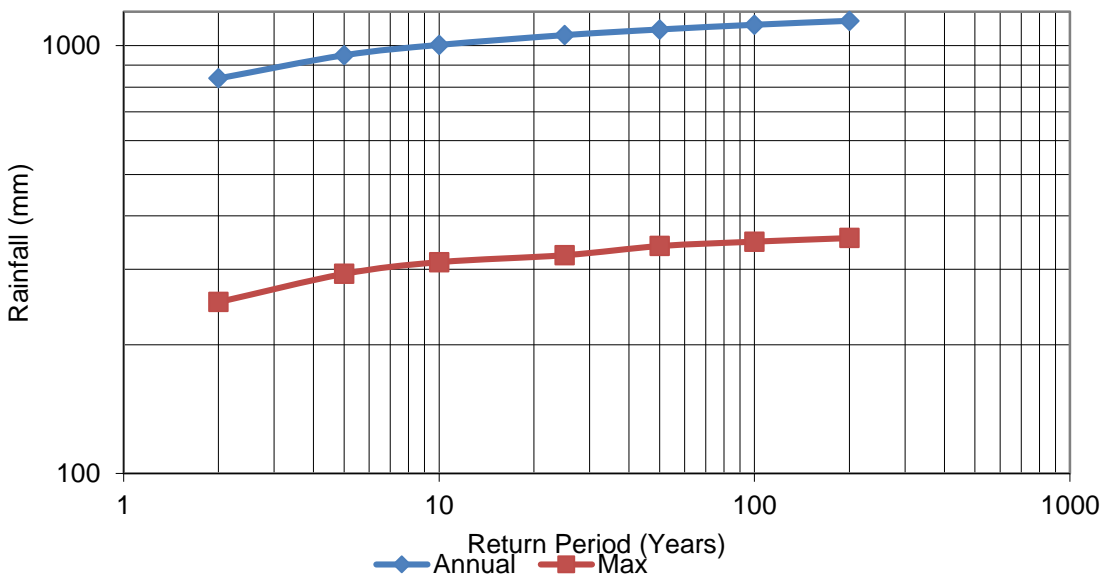
Figure 10: Flood Frequency Analysis for Dadin Kowa using Log-Pearson Type III Analysis using Annual Rainfall Values (1977-2018)

of monthly maximum rainfall in Dadin Kowa is 250.70 mm, 292.80 mm, 313.00 mm, 332.70 mm, 344.30 mm, 353.90 mm and 362.00 mm respectively as shown from Table 2 and Figure 10. The frequency analysis as presented from table 2 showed

the return period of the maximum monthly Rainfall of 344.00 mm is expected to occur in 50 years from 2018 with a magnitude of 344.30 mm. Also, for a recurrence interval of 2, 5, 10, 25, 50, 100 and 200 years of annual maximum rainfall in Dadin Kowa is 838.78 mm, 949.40 mm, 1003.60 mm, 1057.70 mm, 1090.30 mm, 1118.10 mm and 1142.10 mm respectively. The frequency analysis as presented from Table 2 showed the return period of the maximum annual Rainfall of 1119.30 mm is expected to occur in 100 years from 2018 with the magnitude of 1118.10 mm.
