## INFLUENCE OF TRAIN AXLE LOAD ON MECHANICAL BEHAVIOR OF FOULED BALLAST

### ABSTRACT

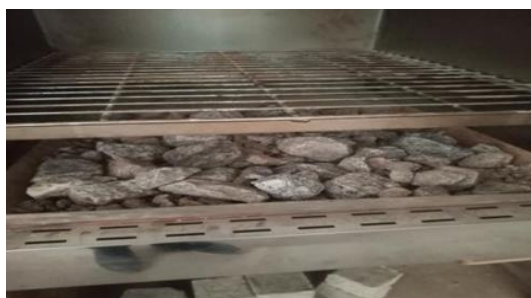
Figure 1a: Clean Ballast Dried in an Oven for 24 Hours

The impact response of 10–60 mm per Selig & Waters (1994) Nigerian granite ballast was assessed using a drop-weight test. Samples were washed, oven-dried at 107°C for 24 hours, and compacted in a rigid cylindrical mould to establish a dry baseline. Impact energy was varied from 37.7 J to 188.5 J by adjusting drop height from 200 mm to 1000 mm with a 19.2 kg hammer, applying 10 blows per height in accordance with EN 13450:2003 on clean ballast and ballast fouled with lateritic fines at 10%, 30%, and 50%. Permanent settlement, deformation ratio, resilient modulus, and post-test Ballast Breakage Index were recorded to quantify degradation.

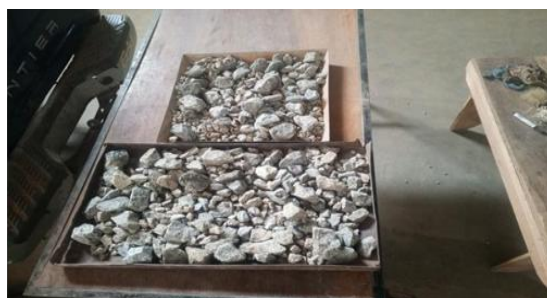
Figure 1b: Ambient temp cooling of clean ballast

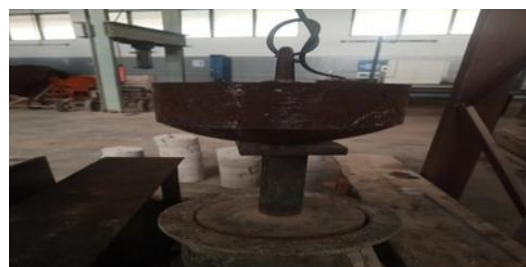
Figure 1c: During fallen height test

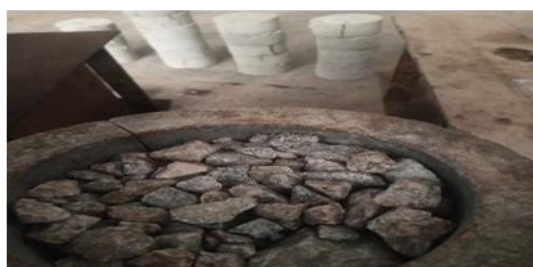
Figure 1d: Settlement after fallen height test

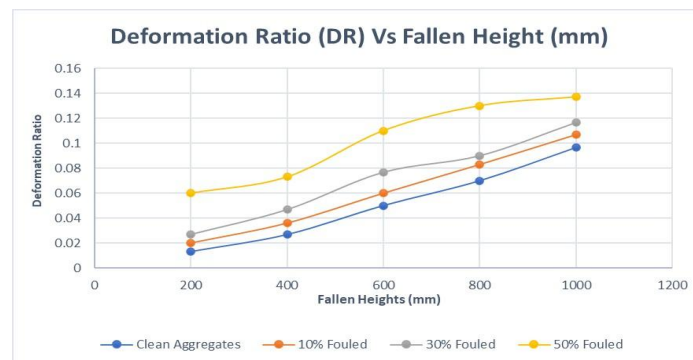
Figure 3: Deformation Ratio vs Drop Height for Clean and Fouled Ballast (0%, 10%, 30%, 50%)

Figures 2 and 3 show resilient modulus decreases and deformation ratio increases systematically with fouling and deformation, confirming deformation ratio as a strong degradation indicator. A critical transition occurs at 30% fouling, where ballast behavior shifts from elastic to inelastic, causing accelerated settlement and poor load distribution. Clean ballast maintains superior elastic recovery, while heavily fouled ballast behaves inelastically and promotes rapid settlement, consistent with AREMA limits in Table 4.

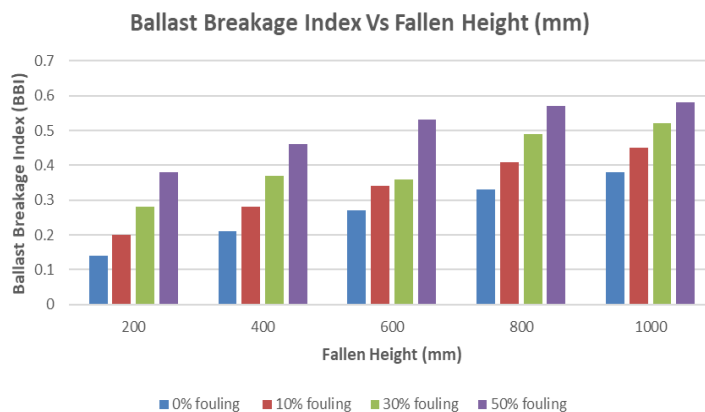
Figure 4: Ballast Breakage Index Vs Fallen Height at 0%, 10%, 30% and 50% fouling

Table 6 and Figure 4 show BBI increases with drop height and fouling. Clean ballast BBI rises from 0.14 at 200mm to 0.38 at 1000mm. At 50% fouling, BBI increases from 0.38 to 0.58, with BBI >0.5 reached beyond 600mm drop. This aligns with Indraratna et al. (2011) triaxial and box test studies, which reported BBI 0.2–0.4 for clean ballast and >0.5 when fouling index FI >30 due to loss of interlock and higher contact stresses. The steeper BBI rise at 30–50% fouling confirms Indraratna’s critical threshold, where ballast shifts from dilatative to contractive behavior. Thus, the impact tests reproduce the similar fouling driven degradation mechanism Indraratna (2010) observed under cyclic loading and confining pressure.
