Effects of Sand Mining Burrow Pits along Kano–Ringim–Hadejia Road, Jigawa State, Nigeria

Photographic Evidence of Environmental Degradation Associated with Sand Mining along the Kano–Ringim–Hadejia Road Corridor

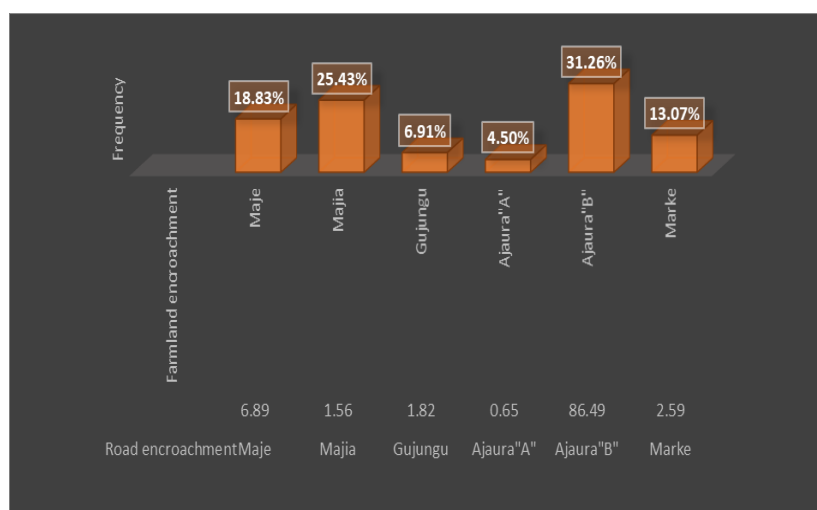
Figure 3 presents the spatial distribution of burrow pit encroachment towards road corridors and adjacent farmlands across the sampled sand mining sites. The figure provides a comparative illustration of the direction and extent of pit expansion, highlighting the relative vulnerability of transportation infrastructure and agricultural land to the impacts of uncontrolled sand mining.

Figure 3: Distribution of Road and Farmlands Encroachments by Sampled Pits

The findings (Figure 3) further indicate that economic pressures and environmental vulnerability contribute to the increasing conversion of farmlands into mining areas. Many

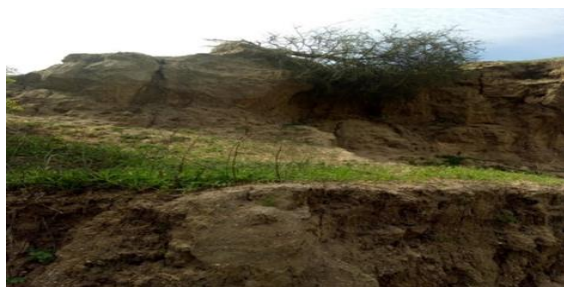
Figure 4: Deforestation and Loss of Vegetation
Source: Field Survey, 2026

The destruction of vegetation was another major environmental problem identified during the study. Vegetation along pit edges and access routes had been cleared extensively to create space for excavation activities and movement of heavy trucks transporting sand. The removal of shrubs, grasses, and trees reduced vegetative cover and exposed the soil surface to wind and water erosion. According to Ayuba (2005), degradation of vegetation through extractive activities significantly increases surface runoff, soil erosion, and desertification risks in northern Nigeria. Similarly, Mensah (2017) observed that sand mining contributes to ecosystem disturbance and biodiversity loss through indiscriminate clearing of natural vegetation.

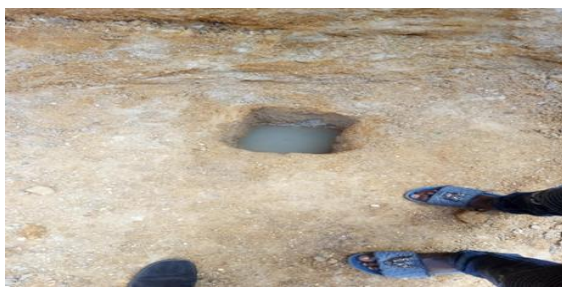
Figure 5: Formation of Pool due to Raised Water Table due to Erosion Triggered by Excessive Sand Mining
Source: Field Survey, 2026

The study also observed that abandoned burrow pits frequently accumulated stagnant water during the rainy season, resulting in the formation of artificial ponds and pools. These stagnant water bodies created breeding grounds for mosquitoes and other disease vectors, thereby increasing environmental health risks within surrounding communities. In addition, some of the pits weakened nearby land surfaces and contributed to landslides and pit wall collapse, especially in areas where excessive excavation occurred without safety measures. UNEP (2019) emphasized that poorly managed sand mining activities contribute to hydrological instability, flooding, and environmental hazards in many developing countries.

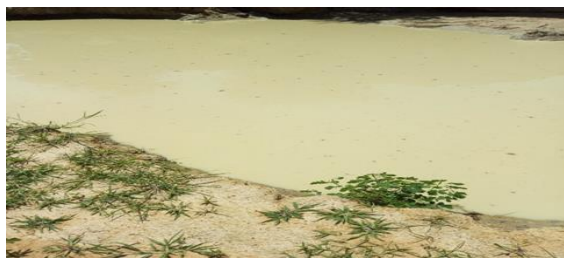
Figure 6: Stagnant water on a Burrow Pit
Source: Field Survey, 2026

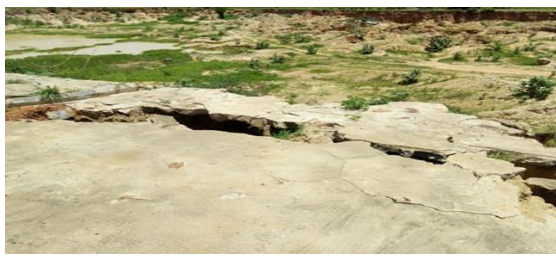
Figure 7: Eroded Barricade Constructed to Avert Road Encroachment from a Neighboring pit
Source: Field Survey, 2026

Another significant environmental problem observed during the study was road encroachment caused by expanding burrow pits and erosion. In several locations, erosion from mining sites gradually extended towards road shoulders, threatening transportation infrastructure along the Kano–Ringim–Hadejia road. Heavy trucks transporting sand also contributed to road deterioration through repeated movement on weak surfaces. Similar observations were made by Lawal (2011), who reported that uncontrolled sand mining contributes to road degradation and increased maintenance costs in mining communities.

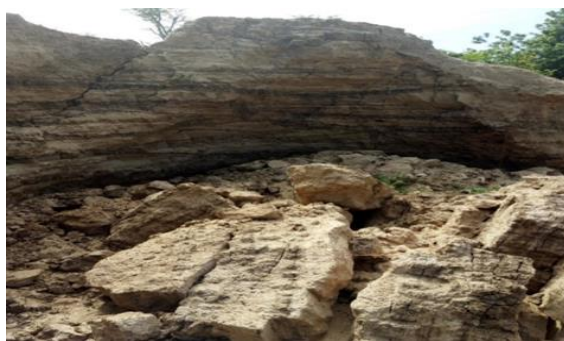
Figure 8: Land slide Caused by Mining of Pit Sand
Source: Field Survey, 2026

Pit collapse and landslides were identified as common occupational hazards faced by miners within the study area. Miners often excavated sand from unstable inner pit walls without protective measures, thereby increasing susceptibility to wall collapse. During fieldwork, evidence of recent landslide events and collapsed pit sections were observed in some mining locations. Akintola (1978) similarly reported that mining activities increase susceptibility to landslides, mudflows, and structural collapse due to weakening of soil stability and alteration of natural landforms.

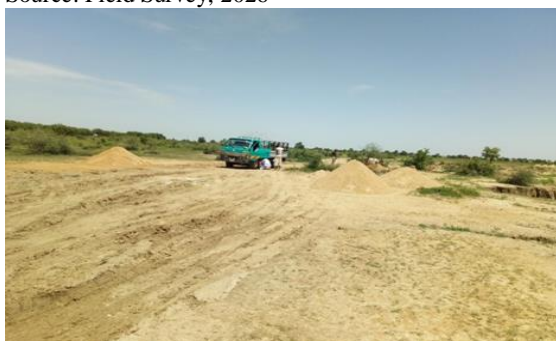
Figure 9: Access Roads Stock Piled by Heavy Vehicles
Source: Field Survey, 2026

Heavy-duty trucks transporting sand also contributed significantly to accidents and environmental hazards along the road corridor. Repeated movement of overloaded trucks damaged access roads, loosened soil surfaces, and increased dust pollution within surrounding communities. According to Mensah (2017), poorly regulated mining transportation systems contribute to increased accident risks, road deterioration, and environmental instability in mining regions.
